ieema
TRAFOTECH
WORKSHOP
& EXHIBITION 2012

SESSION: VI
MAINTENANCE

CASE STUDY - 1

Overhauling of 315MVA, 400/220/33KV, transformer:

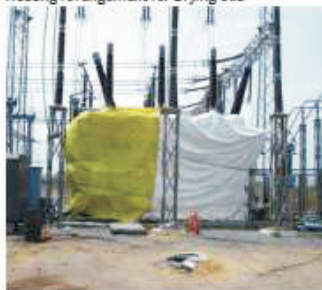
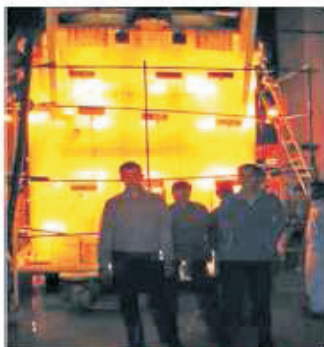
Heating Arrangement for Drying out:

- Drying out of core-coil assembly by vacuum pulling, nitrogen filling and external heating method.
 - Final Dew point of nitrogen was -5° C at temperature of 70° C.

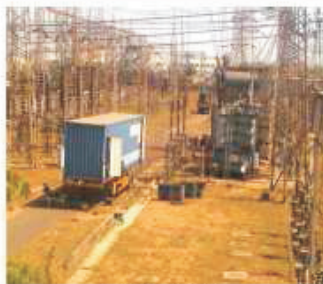
Back View for Plant

The above On-line transformer oil processing technique gave us good results.
